Inspection Report

Minerals Regulatory Program

Mine Name: Myrin Site
Operator or Permittee Name:
W. W. Clyde Obayashi
Permittee Mailing Address:
HC 65 Box 119, Bluebell, Utah 84007

Permit number: S/013/010
Inspection Date: February 3, 2005

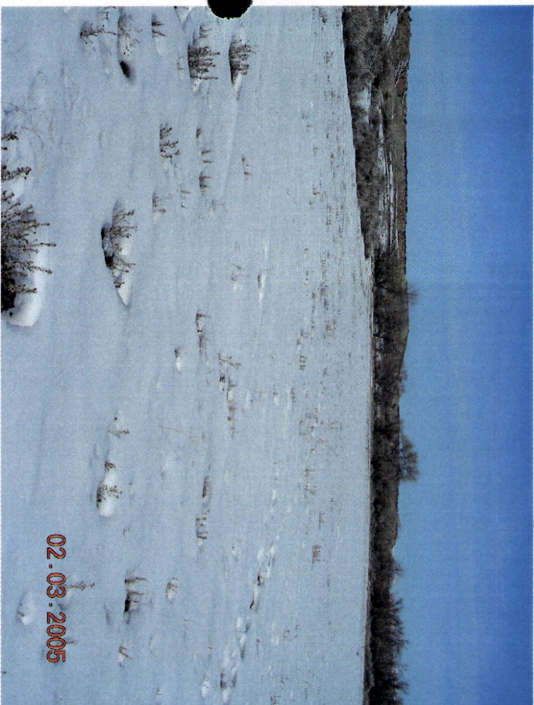
Although most of the area proposed to be mined was covered with snow at the time of the inspection, it appeared there was little vegetation on the site (Photos 1 and 2). The vegetation was mostly halogeton and gumweed with a little quackgrass. Photo 4 shows one area the operator had planned to mine where the vegetation was dominated by gumweed, but this area also contained a fair amount of smooth brome, a pasture grass.

Photo 1. An overview of part of the area the operator would like to mine. Most vegetation in the field is halogeton or gumweed.

A variance from revegetation requirements is justified in most of the area the operator would like to mine because of the lack of vegetation; however, I do believe the site is capable of supporting more vegetation than is currently present. Adjacent areas contain sagebrush which indicates the soils are not particularly saline. As the operator excavates clay from the area, saltier soils might be exposed.

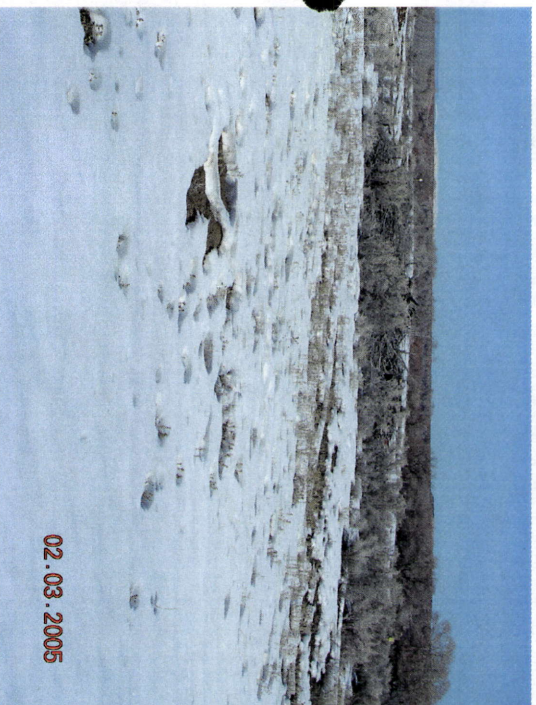
Photo 2. Another view of the area proposed to be mined.

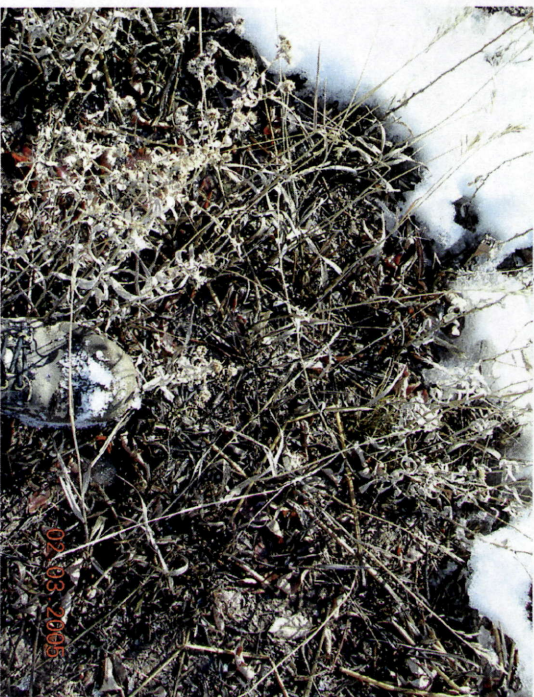
Photo 3. Pasture grasses and gumweed in the field shown in Photo 4.

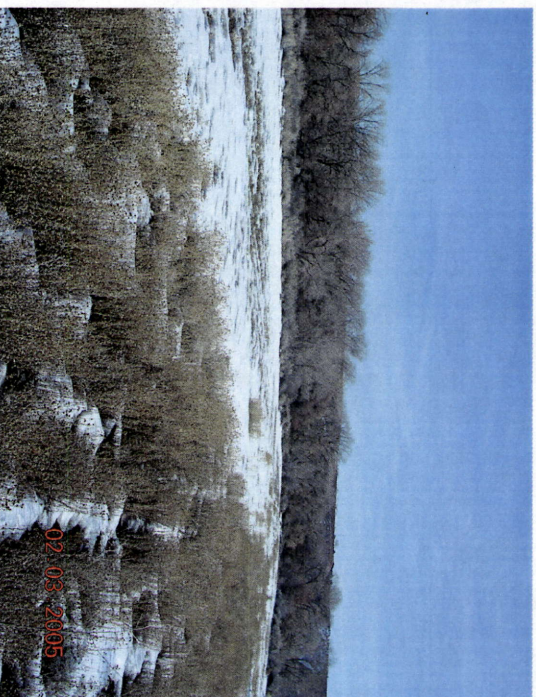
The operator and the land owner need to consider the postmining land use for this area. It appears to have been cultivated land at some time in the past, but I did not see evidence that it was used for pasture or crop land within the past year. There was one area (Photo 4) that might still be used as pasture. I do not envision that the pits could be cultivated, but they might be used for stock watering.

Photo 4. This area has enough vegetation that a revegetation variance would probably not be appropriate. Although most of the vegetation in this photo is gumweed, there is a fair amount of smooth brome.
